Investigation Summary

Capsizing with Loss of Life Small Fishing Vessel *Le Marsouin I*

Quebec Region Standing Committee on Fishing
Vessel Safety
Rimouski, 16 February 2011

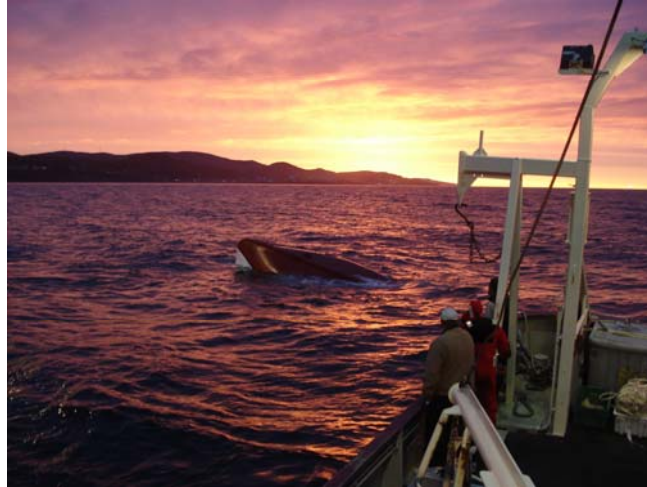
18 May 2009 - *Le Marsouin I* after capsizing

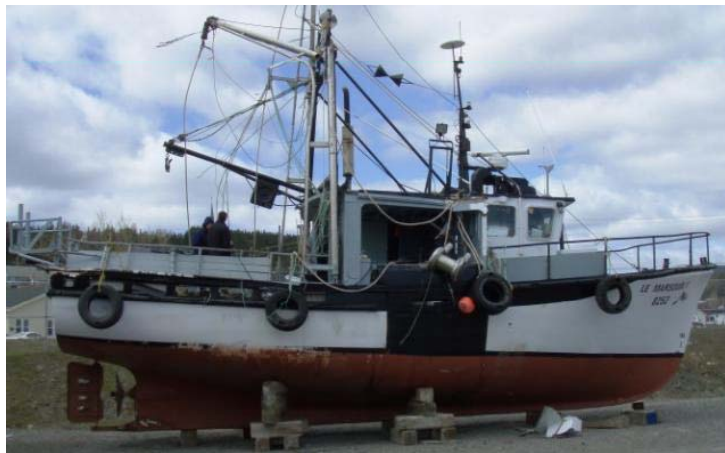
Le Marsouin I after capsizing

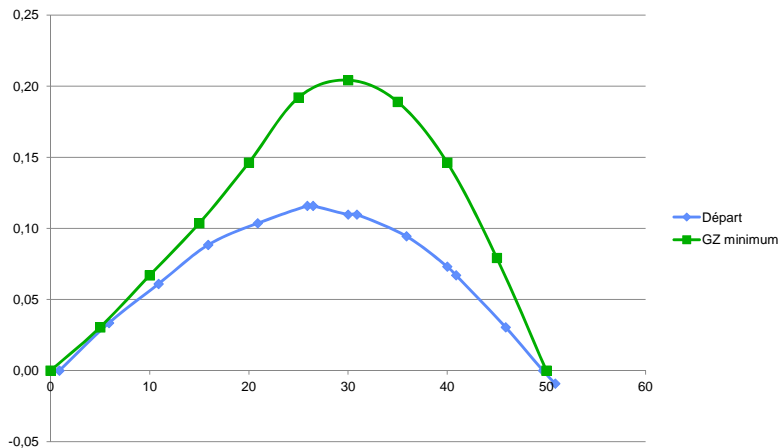
Comparison of righting arm curve in the departure condition with the minimum GZ

- ★ In its departure condition, *Le Marsouin I* had limited stability, even in calm waters. Once underway in the presence of following and quartering seas, the vessel's stability was further reduced.
- ★ As a result of following and quartering seas, the vessel attained a large enough angle of heel such that it reached its angle of vanishing stability and capsized.

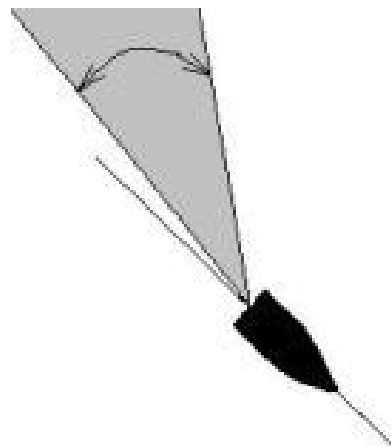
- ★ **Wave Height (0,5 à 1 m)**
- ★ **Wave Direction (320 à 350 degrees)**
- ★ **Vessel's Heading (135 degrees)**
- ★ **Stern and Quartering Seas**
- ★ **Angle of Encounter on Port Quarter**
- ★ **Wave Period (3 to 4.5 seconds)**
- ★ **Period of Encounter (9 to 26 seconds)**

Angle of encounter of the wave with the boat

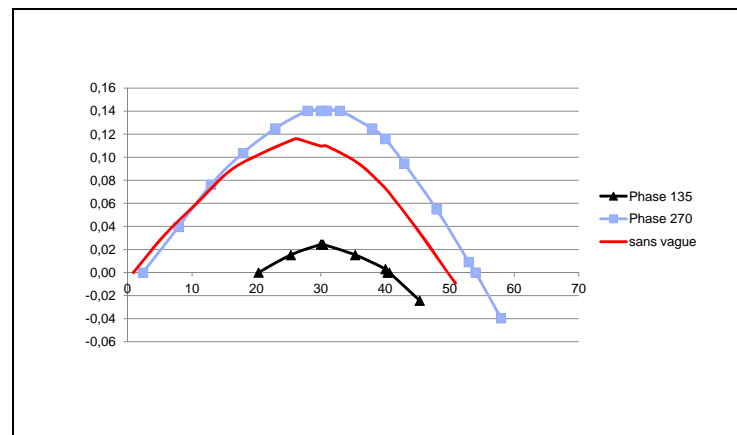
GZ Curves as a function of the position of the wave crest

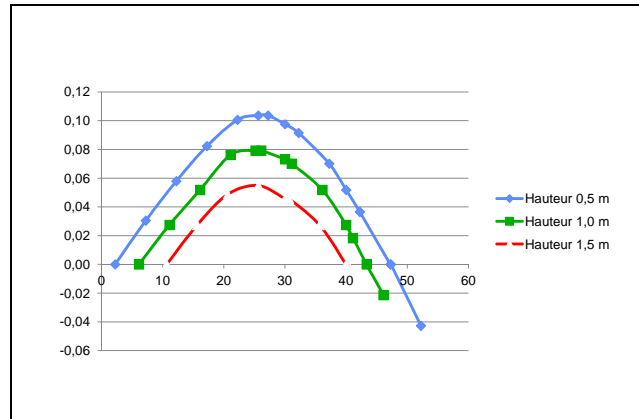
GZ Curves as a function of wave heights

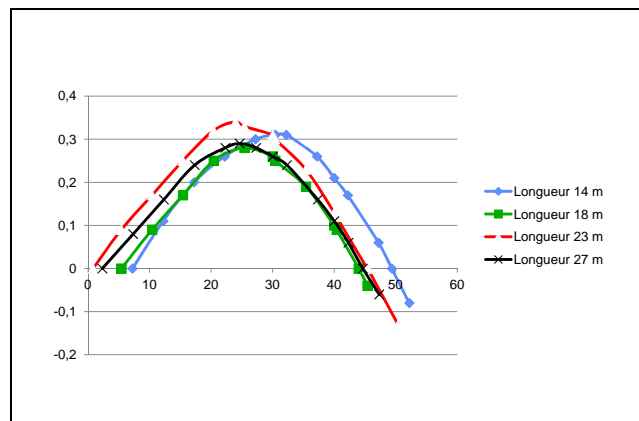
GZ Curves as a function of wave height /
length ratio

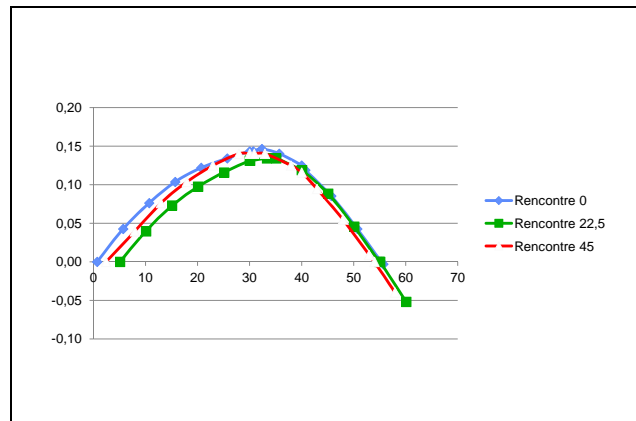
GZ Curves as a function of the angles of encounter

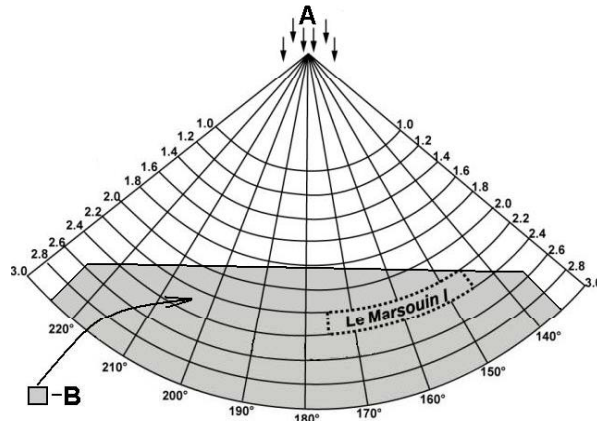
Diagram of risk of surfing

A : Wave Direction ; B : Risk Zone

- ★ **Knowledgable about sea conditions**
- ★ **Vigilance**
- ★ **Training**
- ★ **Stability Assessment**
- ★ **Modify the vessel's speed**
- ★ **Modify the vessel's heading**
