Transportation
Safety Board
of Canada

**Fire and sinking of the
Fishing Vessel *Frederike. C-2*
Rimouski (QC), Canada
28 April 2015**

Marc-André Poisson
Transportation Safety Board of Canada
09 February 2017

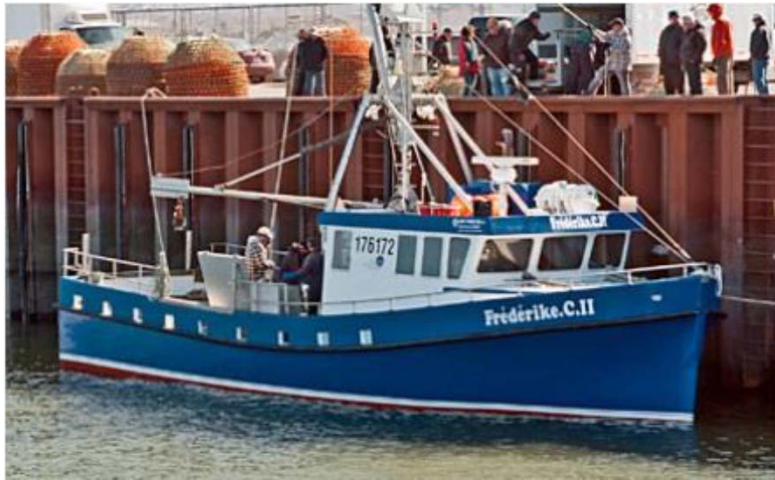
Frederike. C-2 (Source: Fabienne Gingras)
